TECHNICAL DATA SHEET

WIND TIE-DOWN CONNECTIONS – GETTING IT RIGHT

RECOMMENDED PRACTICE // JUNE 2014

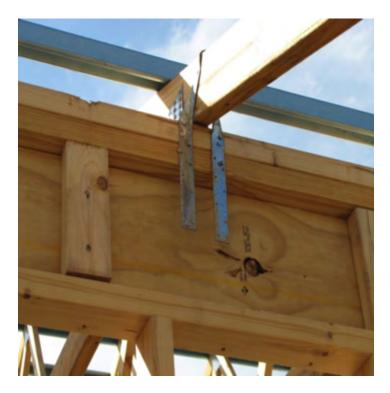
Photograph 1 - Inappropriate practices as nails are too close to strap edge, too close to pre-punched holes and even doubled up. Strap should also have been installed on the inside of frame to enable strap nailing direct to lintel without bending the strap

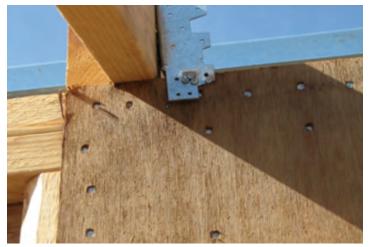
Photograph 2 – A structurally inadequate and incorrectly installed multi-grip. Nails too close to each other and edge of metal and also, too close to top edge of top plate

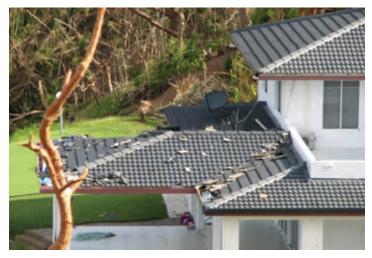
Photograph 3 – Inadequately fixed tiles dislodged after high wind event

Cyclones Larry and Yasi revealed deficiencies in fixing methods for tile roofs. This resulted in new requirements (N4, C2 and C3) that require every tile (whole, cut, ridge and hip) to be mechanically fixed with screws, clips or other mechanical method as recommended by the manufacturer. Bedding compounds are no longer permitted for tying down tiles in these high wind regions.

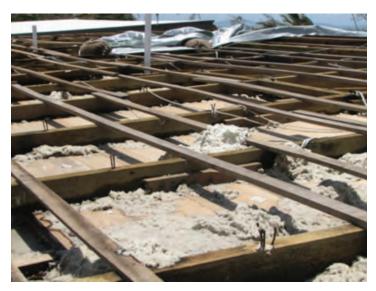
Photograph 4 – Roof sheeting 'blown' off due to inadequate fixing of the sheeting to the battens

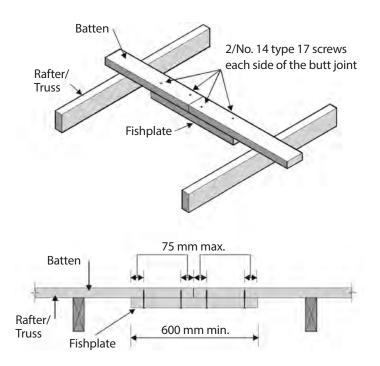
Figure 2 – Joining battens between supports

The joining of battens at supports can be achieved by the methods given in Figure 1, and an acceptable method of joining battens between supporting trusses/rafters is shown in Figure 2.

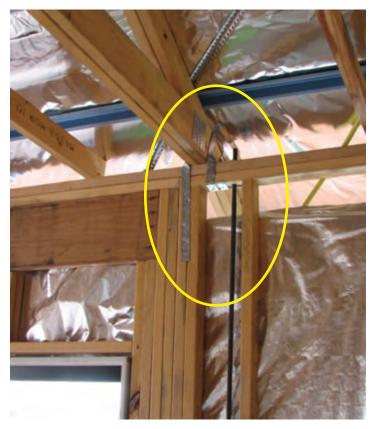
Photograph 7 – Double straps connecting girder truss to top plate and jamb studs (strap to jamb stud should have been centrally located on stud). Cyclone rod correctly located within 100 mm of truss tie-down

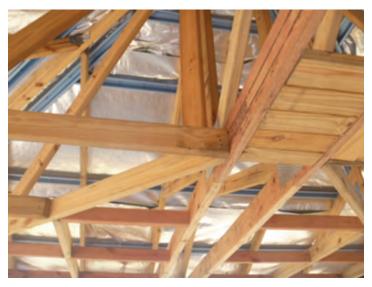
Photograph 8 – Inadequate connection of jack and hip trusses to girder truss for a C2 wind classification

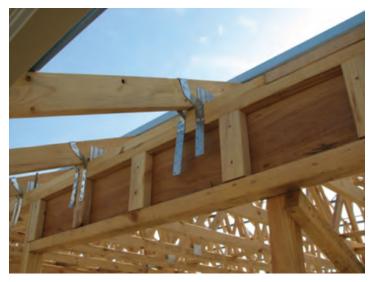
Photograph 9 – Incorrect practice for tying down over openings as top plates not tied to lintel

At openings, tie-down of the top plates can only occur at the sides of the opening. Therefore, trusses and rafters that are tied down over the opening are required to be tied to the lintel to transfer uplift loads back to the tie-down points either side of the opening. Top plates, typically being a double standard plate are not capable of spanning, in uplift, between tie-down points either side of openings.

- Tie trusses/rafters to top plate and then within 100 mm of this tie top plates to lintels with strap, bolts or similar
- Tie trusses/rafters direct to lintel.

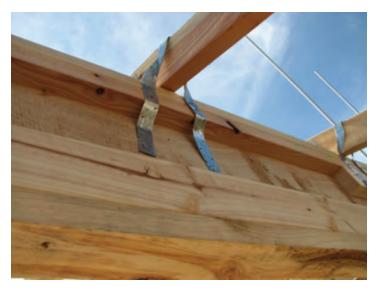
Photograph 10 – Truss tied direct to top plate and lintel, but strap bent through too great an angle to be effective

[Note: The truss to the far RHS is tied to a block nailed to the lintel. This would be satisfactory as the strap is not bent as long as block had sufficient nails into lintel.]

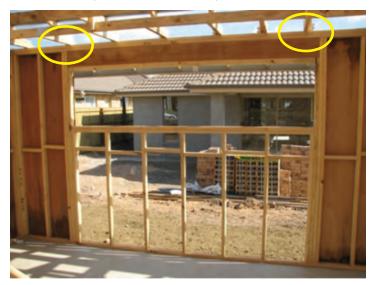
Photograph 11 – Plywood cannot be used to effect tie-down at sides of openings as the trusses highlighted above must have 300 mm min of ply to the right and left side respectively

A practice that has mistakenly been considered acceptable (mainly in non-cyclonic areas) has been the use of plywood at sides of openings to effect tie-down of top plates to bottom plates. Plywood bracing can be used for tie-down in the general run of wall frames within prescribed limits, but is not suitable for tie-down at sides of openings because at least 300 mm of ply (top plate to bottom plate) is required either side of the truss/rafter being tied down at the side of the opening and in most circumstances this cannot be achieved. Sides of openings must be tied down by other means.

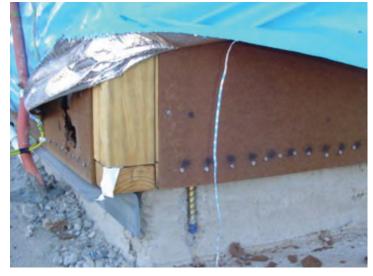
Photograph 12 – Structural integrity totally compromised by excessive bottom plate overhangs

Bottom plates that overhang slab edges present serious challenges in respect of achieving compliant tie-down of the plates to the slab. Where bottom plates overhang slab edges by more than 10 mm it is almost impossible to tie plates down using conventional mechanical or chemical anchors to achieve the minimum slab edge distances required by fastener manufacturers. As well as impacting tie-down, the fixings required at the ends of sheet bracing walls will also be compromised. Other issues that may also be affected include:-

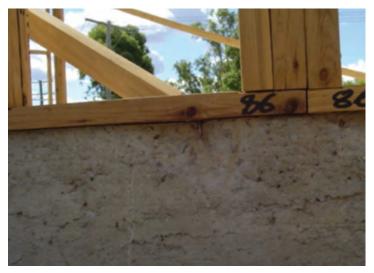
Photograph 13 – Nominal bottom plate connection compromised by excessive plate overhang

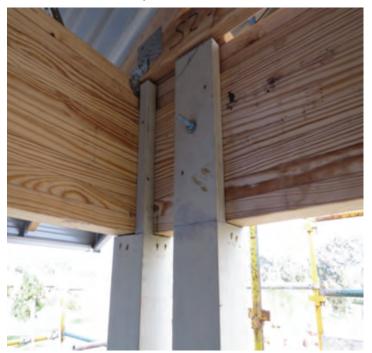
Photograph 14 – Posts over checked, bolted connection would not achieve any tie-down capacity

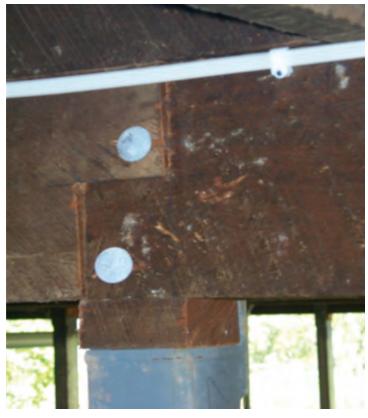
Photograph 15 – Minimum bolt end distances less than required to achieve uplift capacity. Also, unseasoned timber packer used is not suitable due to shrinkage

Bolts - 5 x bolt diameter Screws - 10 x screw diameter Nails - 20 x nail diameter (10 x dia. if nails holes are pre-bored)

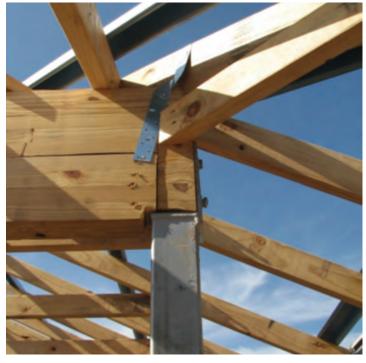
Photograph 16 – Intersecting verandah beams. The LH beam has inadequate bearing and tie-down capacity
